Recovery of Stream Habitats at Managed Grazing Sites in the West Walker River Watershed, Mono County, CA

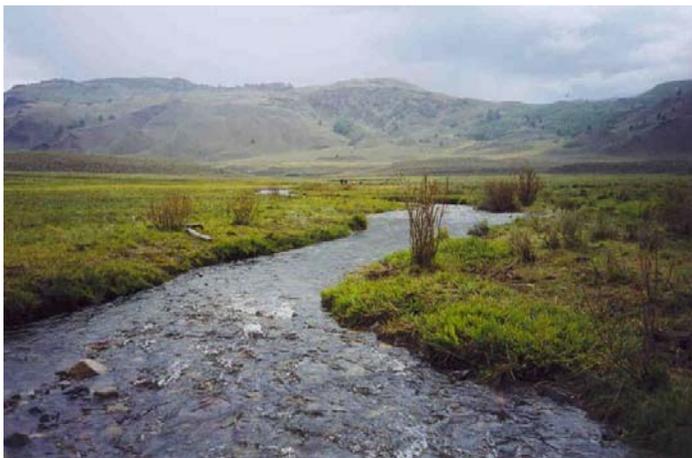
At start of Project at One of Medium Stream Sites (1999)

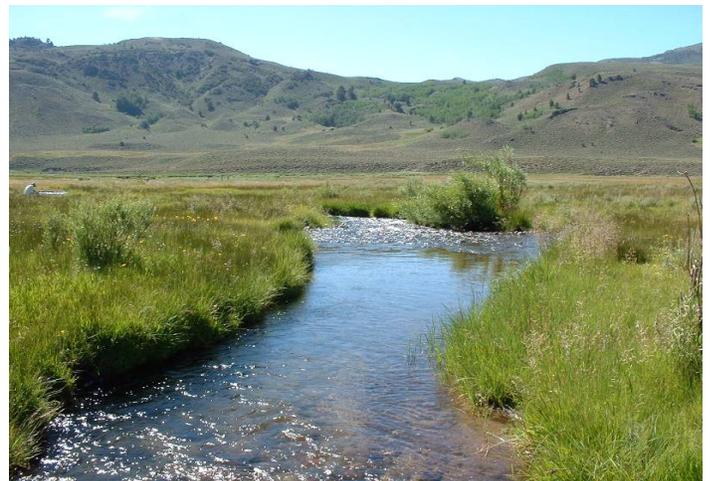
Three years after management measures were in place (2002)

Many of the planted cottonwoods survived the first year but eventually died due to lack of water and browsing by deer or stray cattle. However, photo point monitoring showed that willows were established naturally and abundantly within the fenced areas.

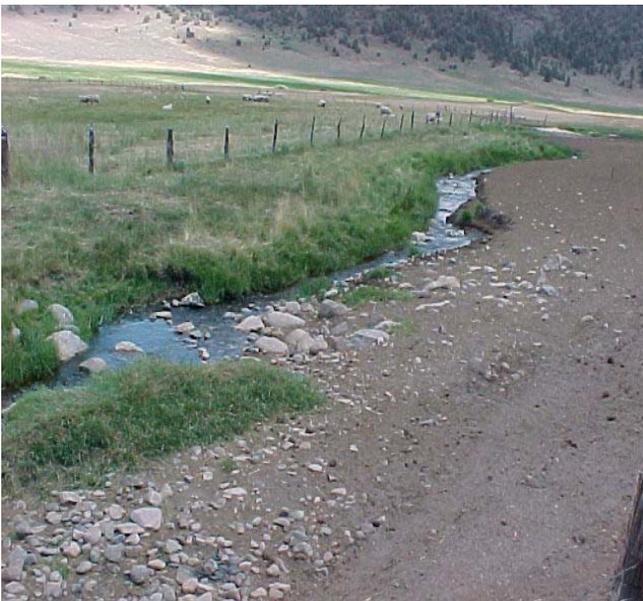
Exclusion Fencing Installed at the Project Site

private ranchers, the CA Department of Fish and Game (CDGF), the Lahontan Regional Water Quality Control Board, UC Santa Cruz and USFS over four miles of exclusion fencing was built, several hundred black cottonwood tree cuttings were planted, and changes to irrigation diversions were completed. Monitoring at managed and controlled sites at small, medium and large streams in the watershed was completed to establish baseline conditions. Stream size was

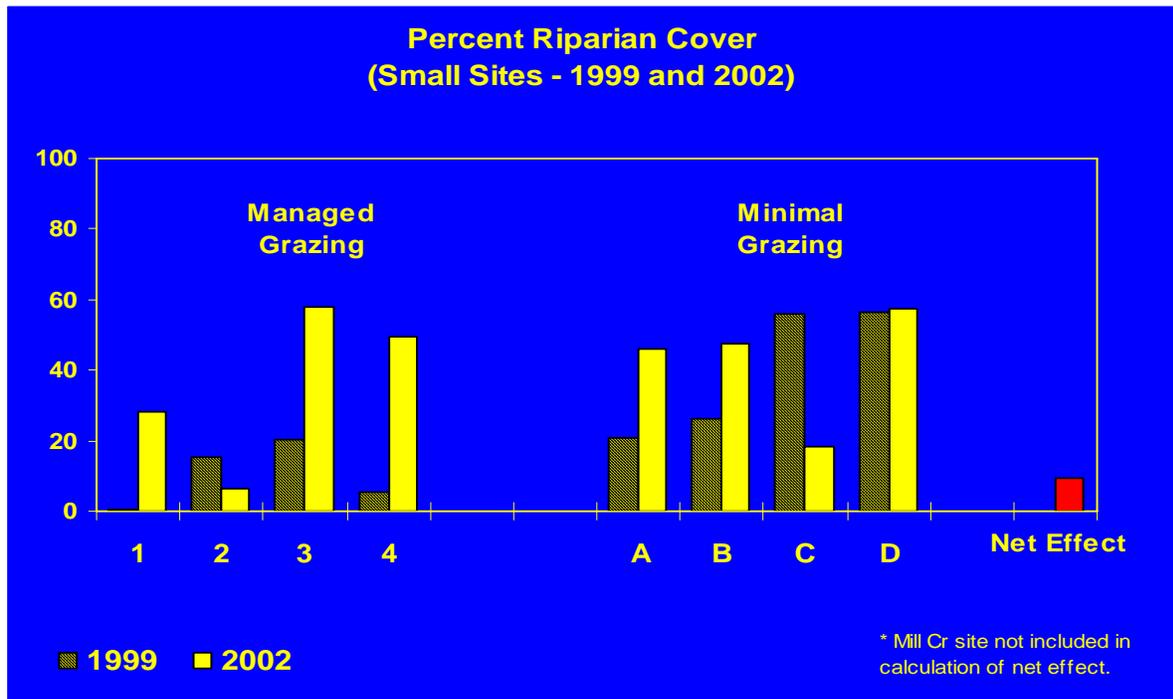
Graph shows increases in riparian cover at small stream sites with grazing management practices in place.

Most managed sites showed a trend toward recovery based on habitat parameters. Monitoring at small, medium and large stream sites over three years showed that riparian cover (streamside vegetation) at most managed sites increased compared to the control sites.

Riparian cover shades the stream, lowers water temperature and provides habitat. Stream bank stability also increased at most managed sites, resulting in less damaging soil erosion. However, stream biota (aquatic insects and other invertebrates) did not show recovery at the managed sites over the three-year monitoring period. These results indicate that vegetation and instream physical habitat are better indicators for short-term (i.e., 3-year) monitoring of rangeland management practices. Long-term monitoring may well be needed to show improvements in stream biota where rangeland management practices are installed.
